Dam and intake remediation of the Laxá powerplant III, North Iceland

H. Hrafnisdóttir

G. R. Stefánsson, G. Pétursson, G. Björnsson, E. Erlingsson

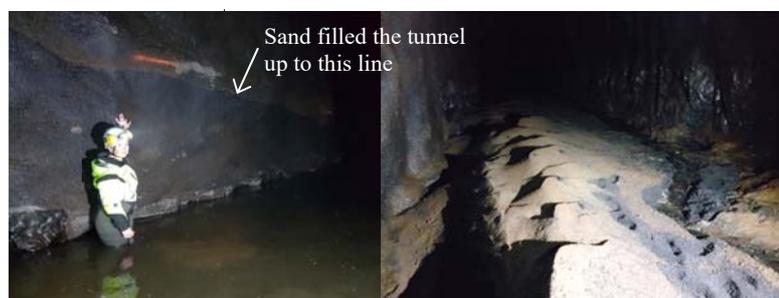
Fig. 2. Left: Traces of black sand on tunnel wall show how much sand was moved from the upstream end of the tunnel. Right: Sediment in the lower part of the tunnel before removal.

quickly filled with sediments and the additional sand transported through. Figure 2 shows examples of sand that had settled in the intake tunnel. This sand is highly abrasive and reduces the lifetime of the mechanical parts.

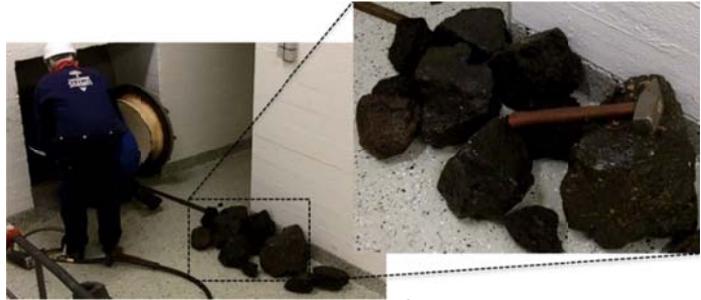
Stones have been transported with ice into the turbine. This material would never enter without the help of ice lowering the density of the larger stone/ice particle. These incidences have resulted in broken bolts, reduced power production temporarily and in severe cases, when the stones are too large to pass through, results in down time while the stones are being removed. These stones also reduce the lifetime of the mechanical parts.

Fig. 3. Stones removed on March 22nd in 2011. Estimated size of largest stone about 40 cm.

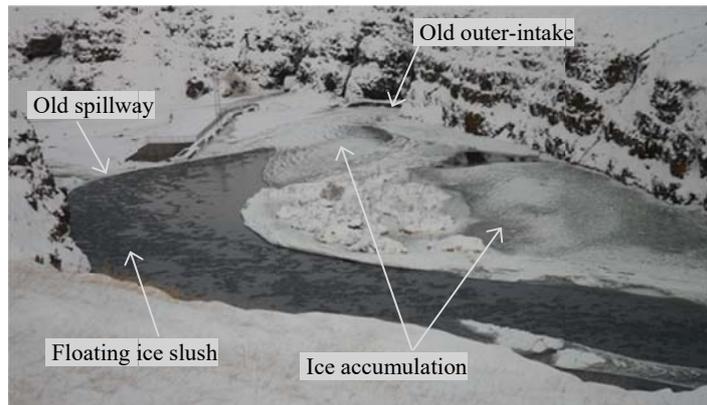
The location of the ice skimming spillway above the intake was based on experience elsewhere, where the base line was that the likeliness of ice skimming working increased if the spillway was located close to the intake. Videos from the intake pond and the dam for Laxá III pointed in the same direction and showed well how only a small portion of the ice slush carried with the water passed over the old spillway while most of the ice was being carried with the main flow towards the intake.

Fig. 7. Overview of the intake pond, intake and dam for Laxá III before changes. Ice slush transported with the flow, part flowing over the old spillway, but much transported with the main flow to the intake.

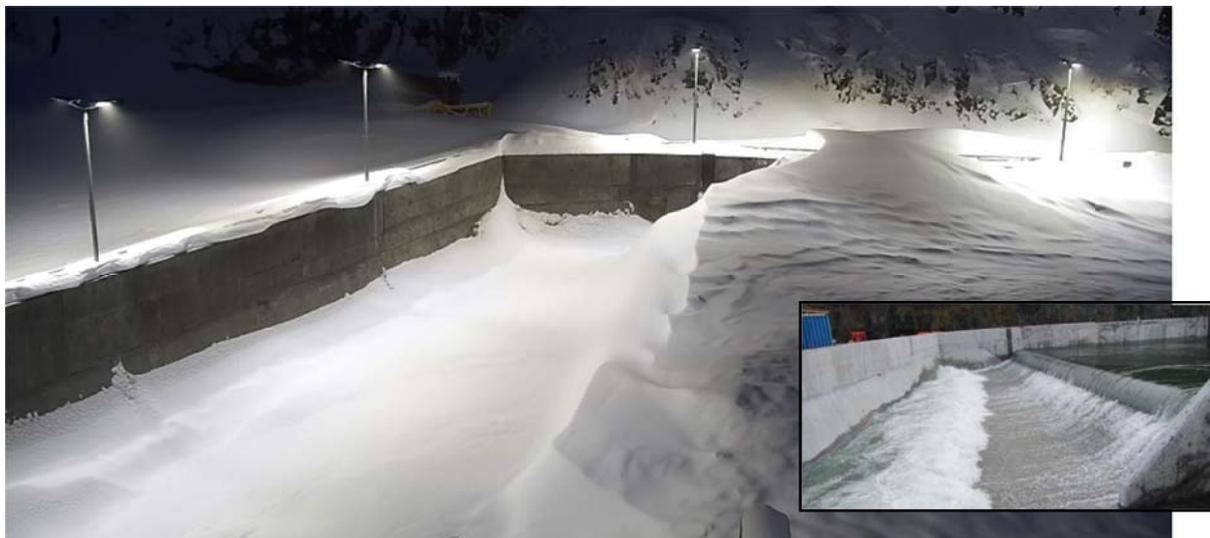
The ice skimming spillway worked well before the removal of the second cofferdam when the intake pond was much smaller and narrower, and the old spillway was being rebuilt and thus not operational. During operation in winter time when the cofferdam had been removed, it has only worked for a short time before becoming blocked with ice.

Fig. 8. The ice skimming spillway and lowest part of intake pond covered with ice formation and snow in February 2019. Small figure to right: summer conditions.

The reason is most likely one of or a mixture of two of these:

- The velocity within the intake pond is most likely too low, allowing ice to slow down and accumulate upstream of the ice skimming spillway where it has time to thicken, get stronger and grow upstream before it is pushed onto the spillway where it stops and continues to thicken and grow.
- Water level on the ice skimming spillway too low for skimming resulting in accumulation from the spillway and upstream.
- Loss of water over the old spillway.

This will be researched further.
