Dam and intake remediation of the Laxá powerplant III, North Iceland

H. Hrafnisdóttir

G. R. Stefánsson, G. Pétursson, G. Björnsson, E. Erlingsson

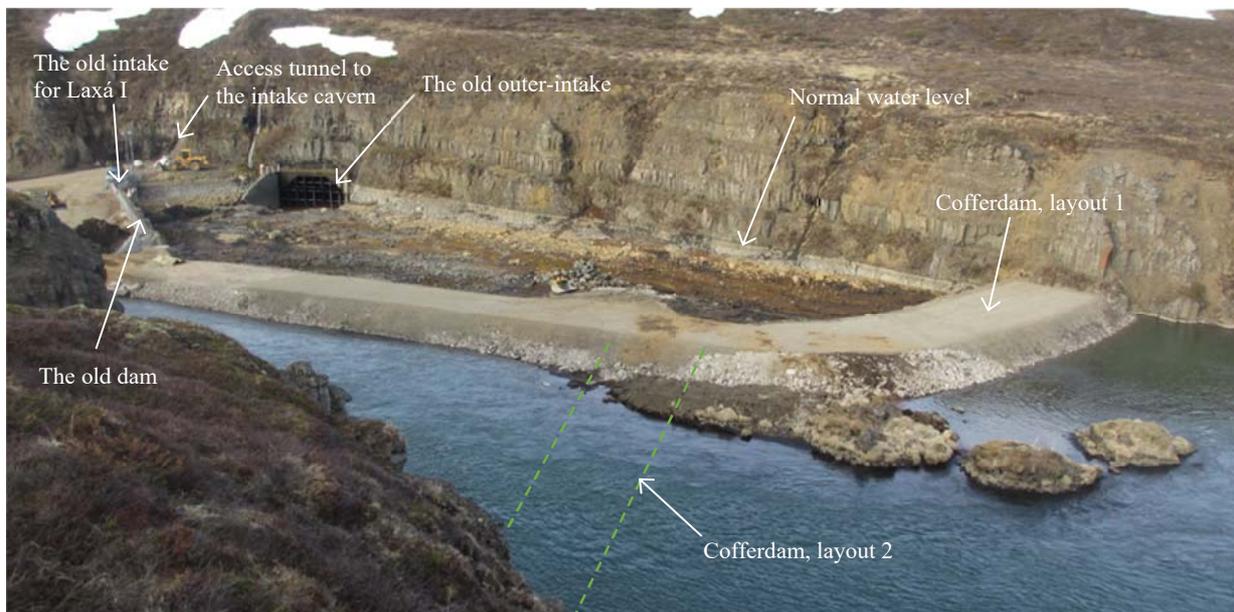
Fig. 4. The construction site in May 2016. Cofferdam, layout 1, ready and part of the intake pond dry. The old dam on the left and the upper part of the old outer-intake visible.

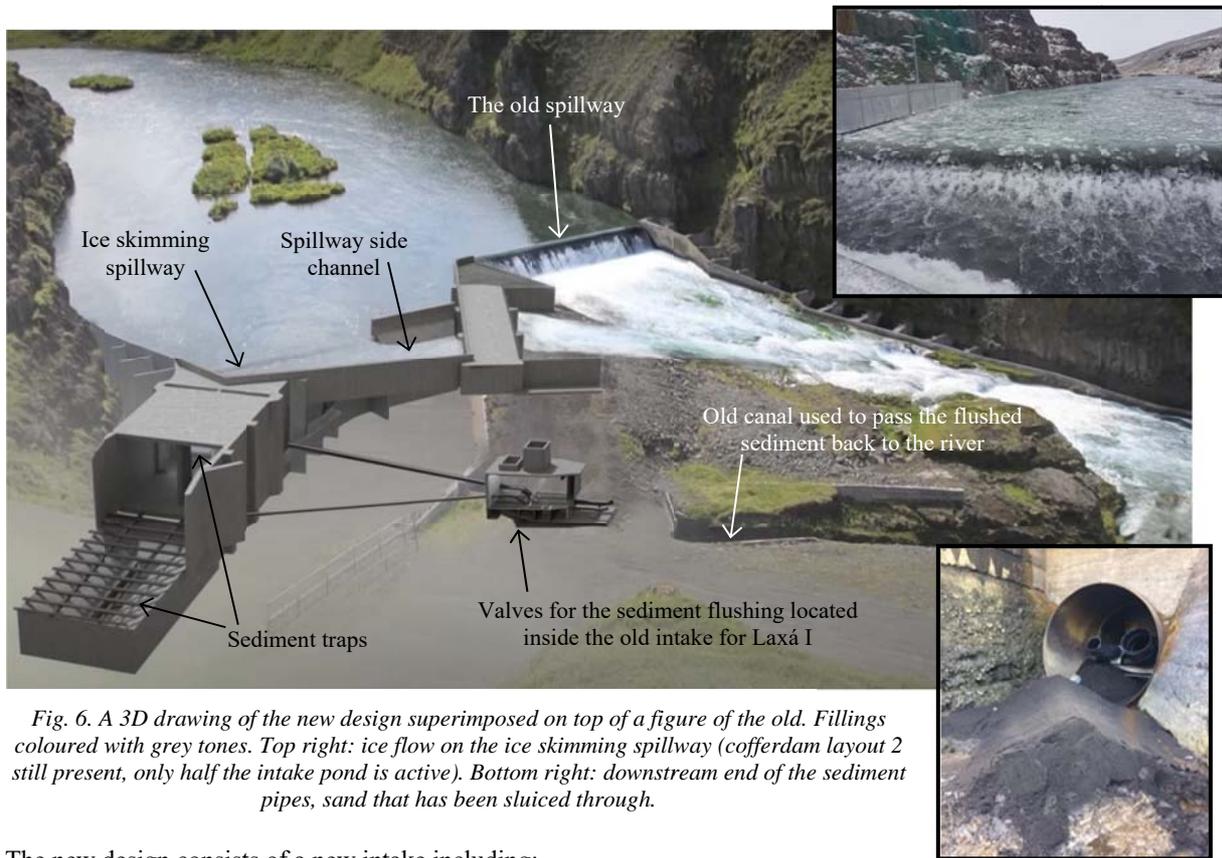
Fig. 6. A 3D drawing of the new design superimposed on top of a figure of the old. Fillings coloured with grey tones. Top right: ice flow on the ice skating spillway (cofferdam layout 2 still present, only half the intake pond is active). Bottom right: downstream end of the sediment pipes, sand that has been sluiced through.
